# In-Service Performance Of HP Concrete Bridge Decks

SPECIAL REPORT 130
TRANSPORTATION RESEARCH AND DEVELOPMENT BUREAU
NEW YORK STATE DEPARTMENT OF TRANSPORTATION
George E. Pataki, Governor/Joseph H. Boardman, Commissioner

Special Report 130 February 1999

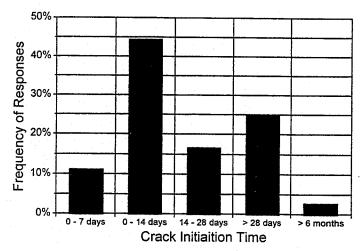
Figure 2. Initiation of cracking.

- 7. Time to first appearance of cracking was also surveyed -- most deck cracks appeared within two weeks after the concrete pour, as shown in Table 8 and Figure 2.
